Deco Flash Testing

Water Intrusion Test Report

Re: "Sample Testing"
Deco Flashing Sample Testing
295 Azalea Drive
Destin, FL 32541

Project Name: Deco Flash Test Sample

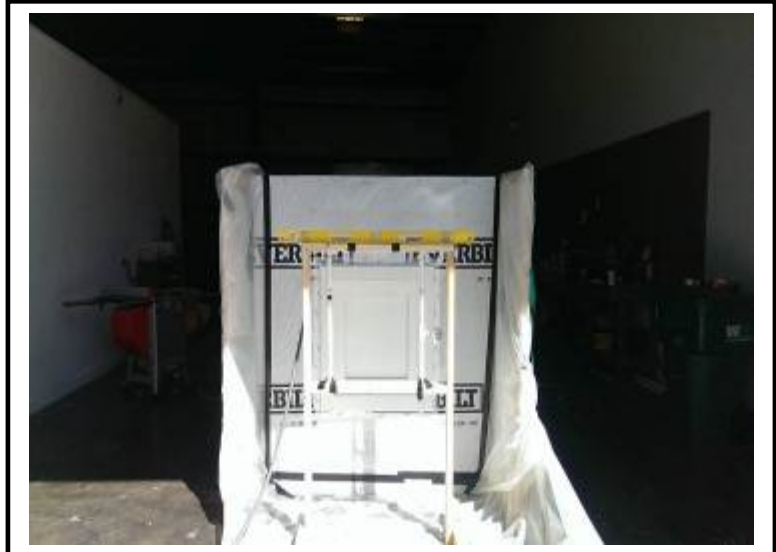
Photo #1.

A view showing the wooden spray rack and attached spray manifold leveled and squared to the test specimen.

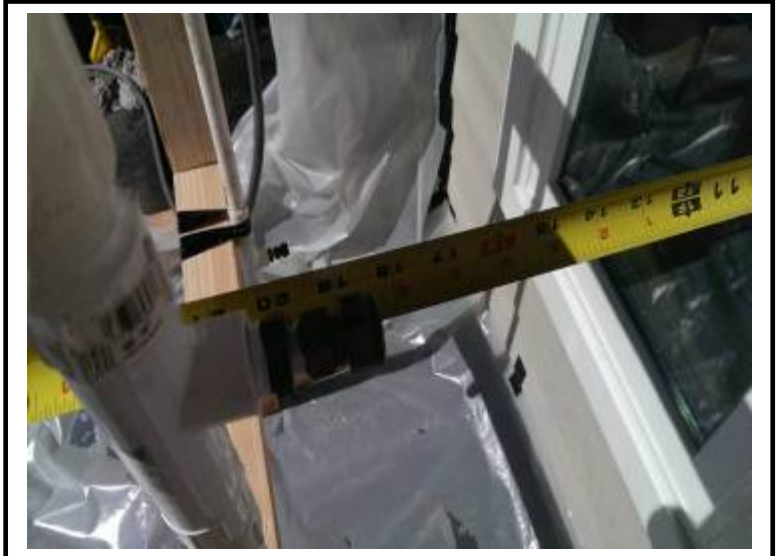
Photo #2.

The spray nozzles were placed 18" from the test specimen as per ASTM E 1105 requirements to deliver the equivalent of an eight inch per hour rain fall on the exterior of the specimen.

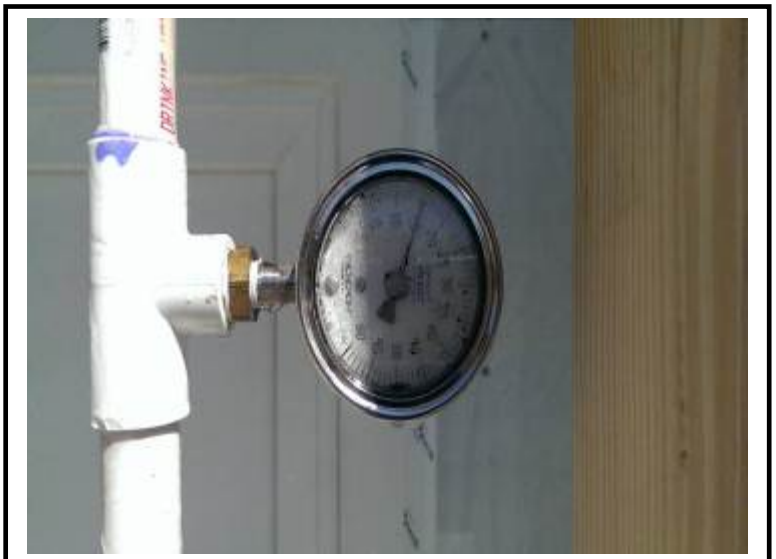
Photo #3.

A water pressure of 15 psi was applied to the spray grid which was attached to a frame assembly that delivers the minimum required coverage of 5 GPH per square foot. This is equivalent to an eight inch per hour rainfall.

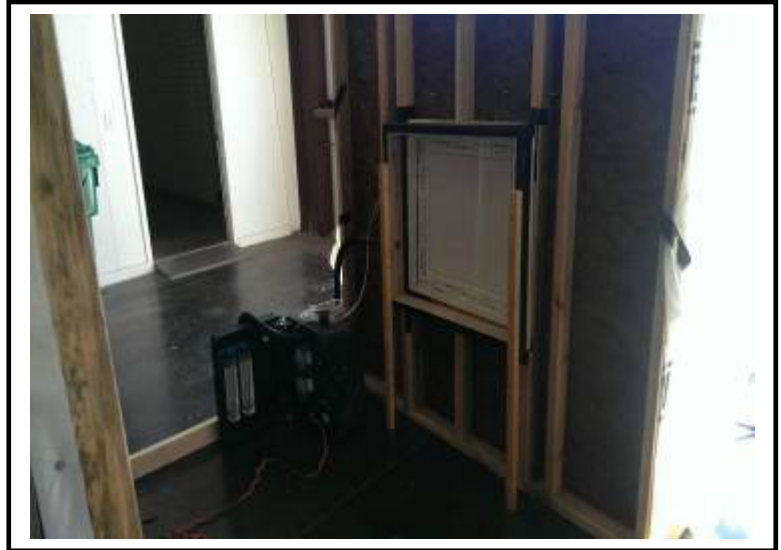
Photo #4.

A view showing the interior of the test specimen. The wooden chamber was placed on the interior portion of the specimen to apply a differential negative pressure on the specimen.

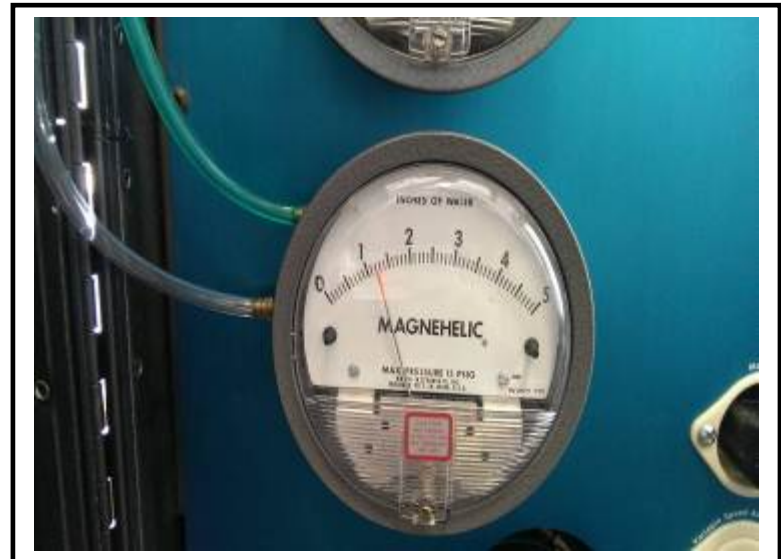
Photo #5.

A view showing the Dwyer Magnehelic gauge reading an interior differential pressure of 1.20 PSF. This is equivalent to 6.24 PSF. This is the minimum required pressure for a fenestration product of this type. The test was run for a duration of 15 minutes. No visual signs of water infiltration were observed throughout the allotted time.

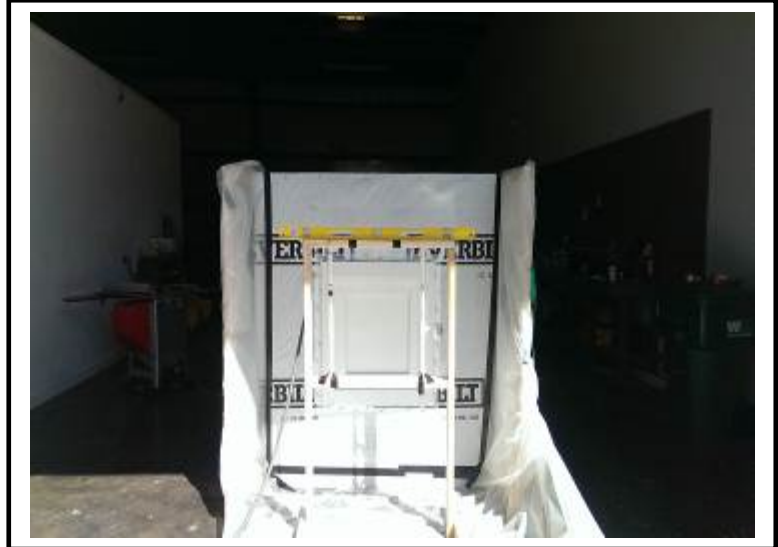
Photo #6.

A view showing the wooden spray rack and attached spray manifold leveled and squared to the test specimen.

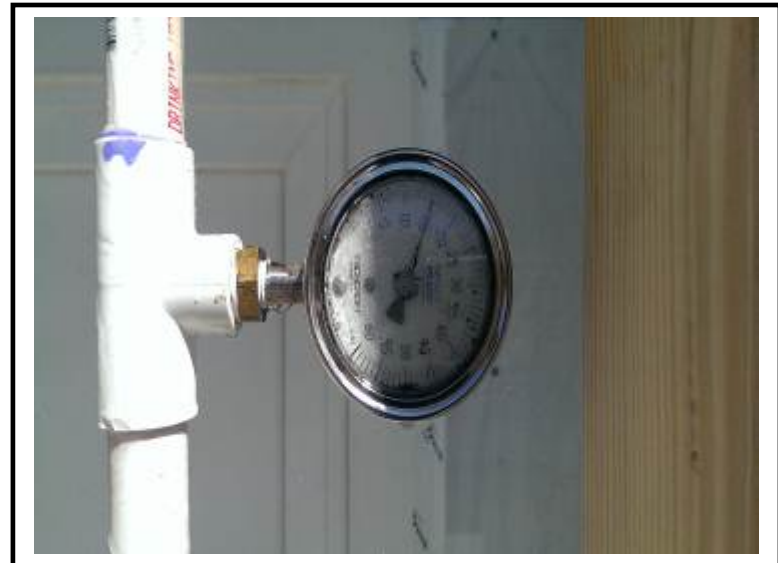
Photo #7.

A water pressure of 15 psi was applied to the spray grid which was attached to a frame assembly that delivers the minimum required coverage of 5 GPH per square foot. This is equivalent to an eight inch per hour rainfall.

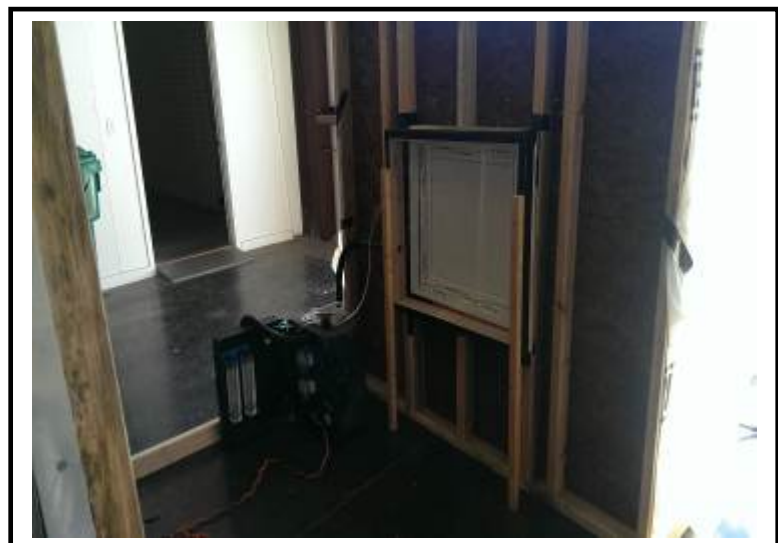
Photo #8.

A view showing the interior of the test specimen. The wooden chamber was placed on the interior portion of the specimen to apply a differential negative pressure on the specimen.

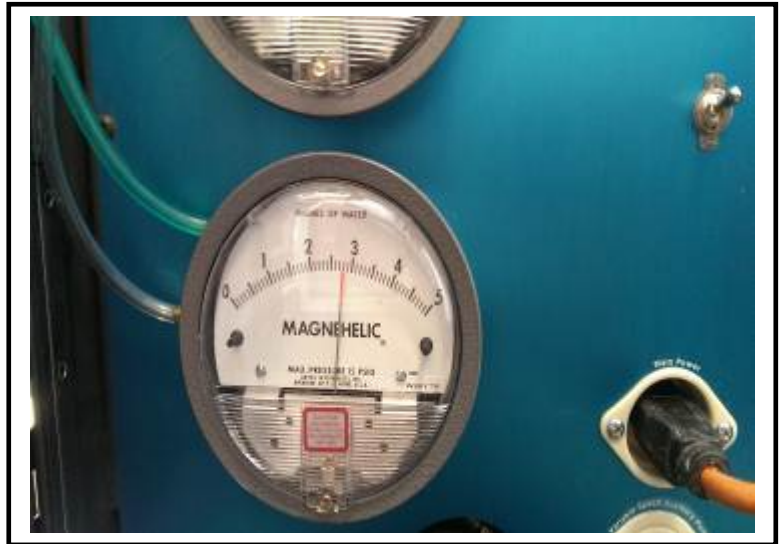
Photo #9.

A view showing the Dwyer Magnahelic gauge reading an interior differential pressure of 2.91 PSF. This is equivalent to 15 PSF. This is the minimum required pressure for a fenestration product of this type. The test was run for a duration of 15 minutes. No visual signs of water infiltration were observed throughout the allotted time.

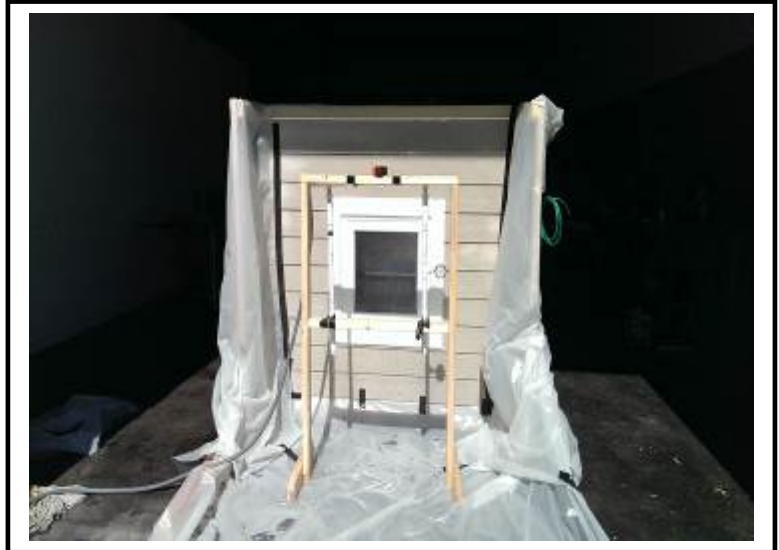
Photo #10.

A view showing the wooden spray rack and attached spray manifold leveled and squared to the test specimen.

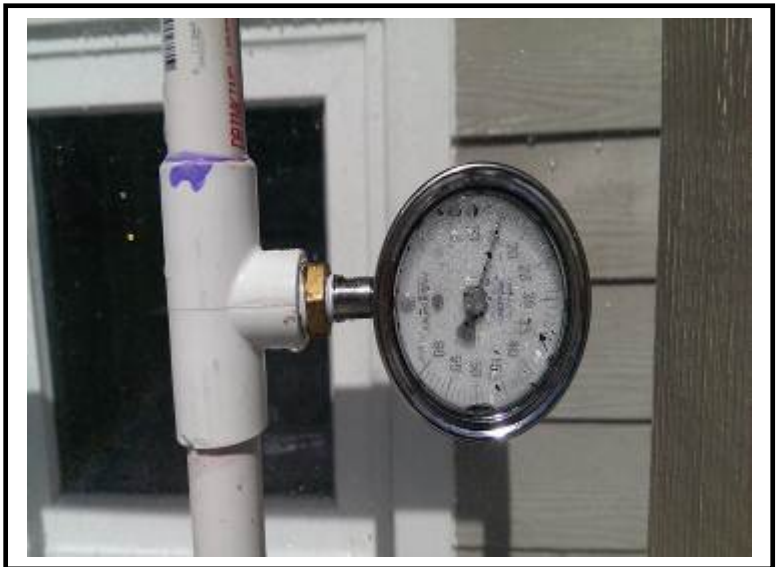
Photo #11.

A water pressure of 15 psi was applied to the spray grid which was attached to a frame assembly that delivers the minimum required coverage of 5 GPH per square foot. This is equivalent to an eight inch per hour rainfall.

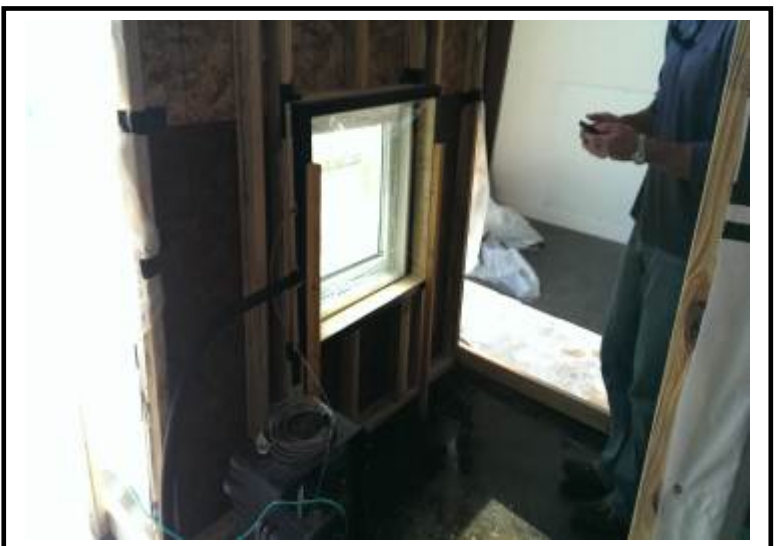
Photo #12.

A view showing the interior of the test specimen. The wooden chamber was placed on the interior portion of the specimen to apply a differential negative pressure on the specimen.

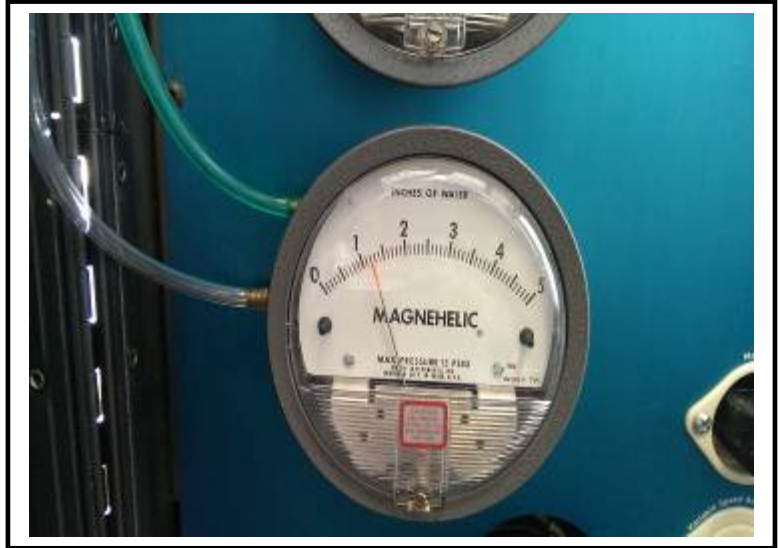
Photo #13.

A view showing the Dwyer Magnahelic gauge reading an interior differential pressure of 1.20 PSF. This is equivalent to 6.24 PSF. This is the minimum required pressure for a fenestration product of this type. The test was run for a duration of 15 minutes. No visual signs of water infiltration were observed throughout the allotted time.

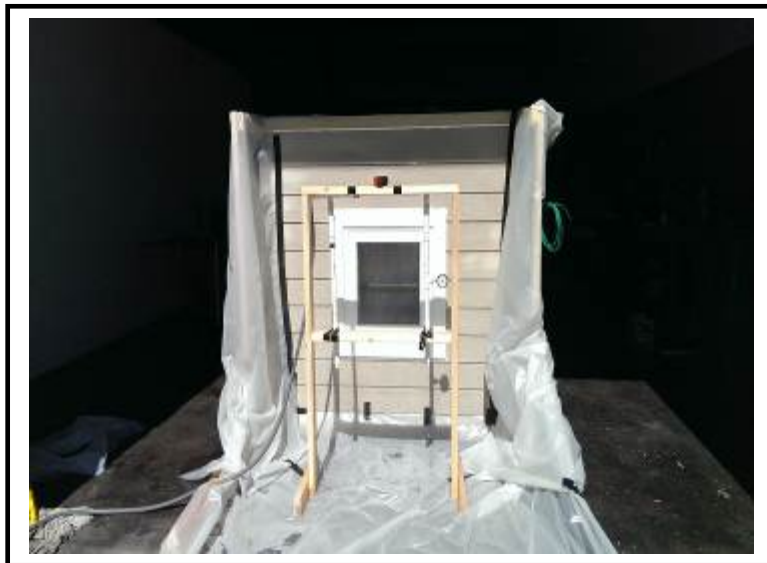
Photo #14.

A view showing the wooden spray rack and attached spray manifold leveled and squared to the test specimen.

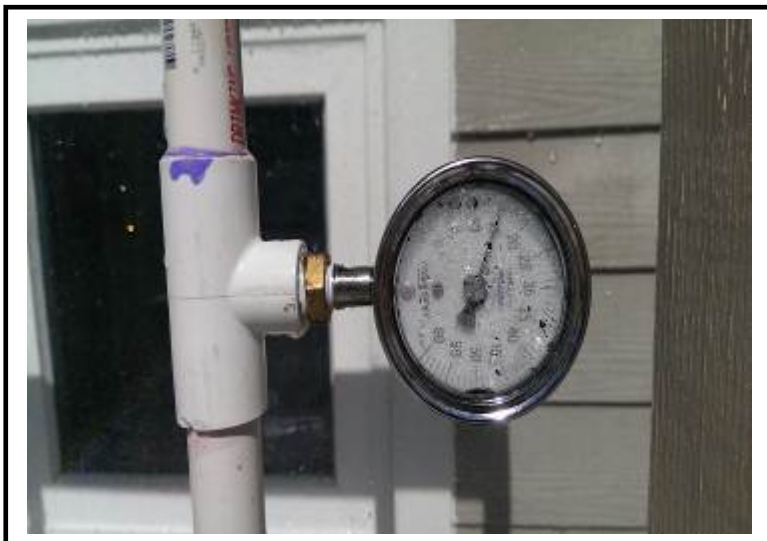
Photo #15.

A water pressure of 15 psi was applied to the spray grid, which was attached to a frame assembly that delivers the minimum required coverage of 5 GPH per square foot. This is equivalent to an eight inch per hour rainfall.

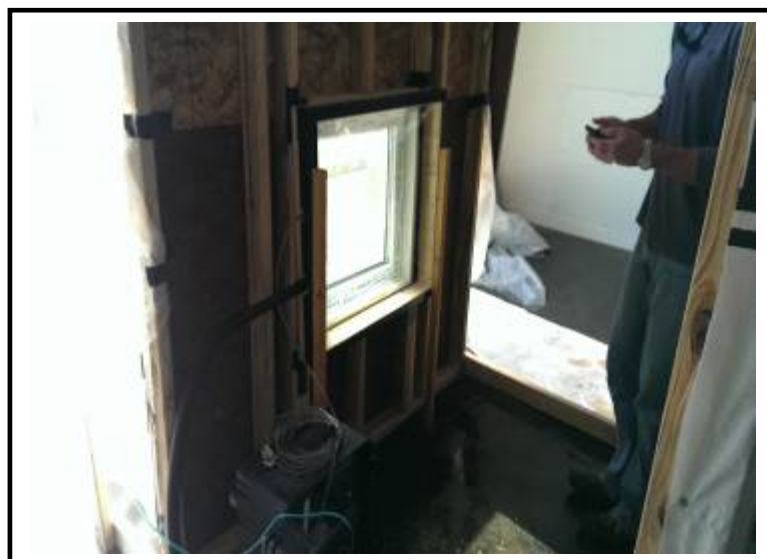
Photo #16.

A view showing the interior of the test specimen. The wooden chamber was placed on the interior portion of the specimen to apply a differential negative pressure on the specimen.

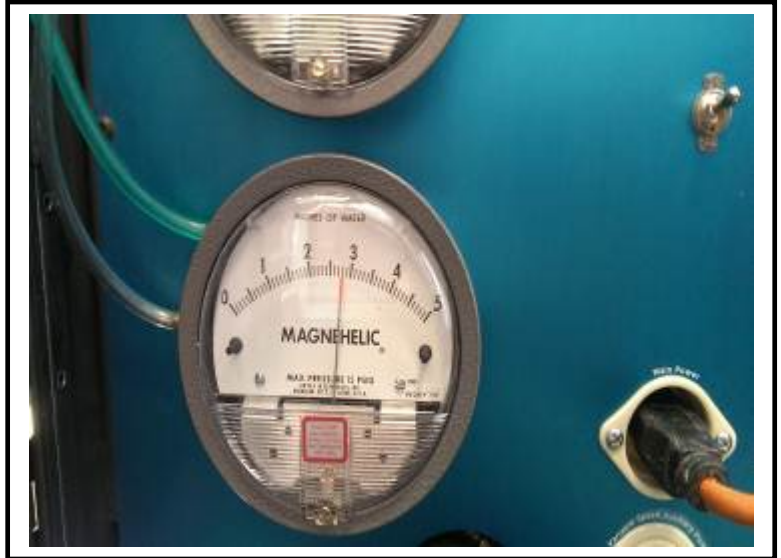
Photo #17.

A view showing the Dwyer Magnahelic gauge reading an interior differential pressure of 2.91 inches of water. This is equivalent to 15 PSF. This is the maximum allowed pressure for a fenestration product of this type. The test was run for a duration of 15 minutes. No visual signs of water infiltration were observed throughout the allotted time.
